**(OPERATION OF A HAYNES ALLOY
NO. 25 FORCED CIRCULATION LOOP
TO STUDY THE EFFECTS OF HYDROGEN
IN A SIMULATED SUNFLOWER SYSTEM)**

by R. C. Schulze and D. B. Cooper

Prepared under Contract No. NAS 5-462 by
THOMPSON RAMO WOOLDRIDGE, INC.
Cleveland, Ohio

NASA CR-225

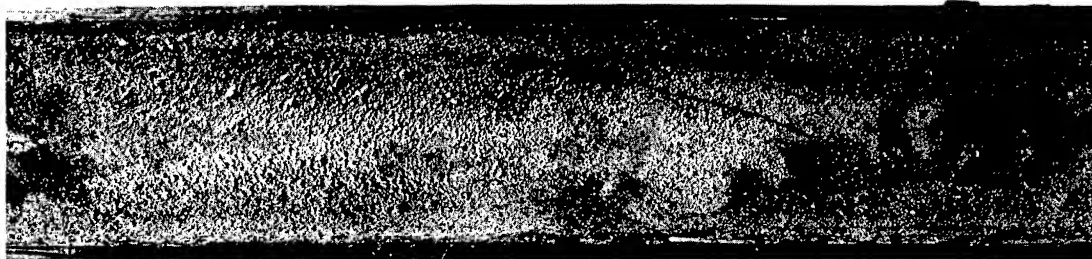
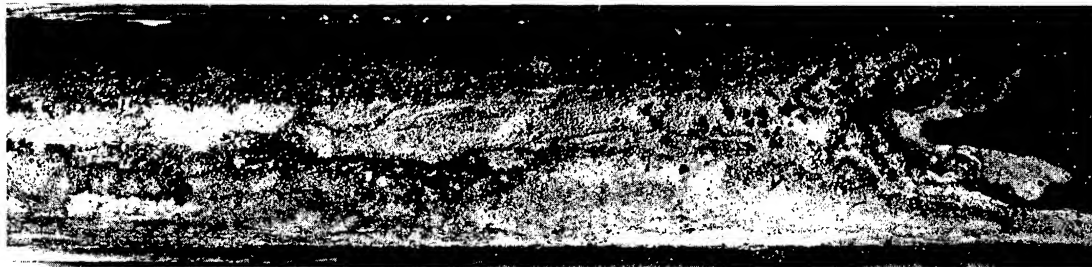
The middle of the superheater (Section 22 and 23) also contained a deposit similar in nature, although, the concentration of the deposit was not as heavy. In general, the deposit appeared to follow the contour of the swirl wire. Figure 40, (macrograph of sections 22 and 23) shows the overall appearance of the I.D. surface of the tubes. Figure 41 (Section 22, thermocouple No. 21) shows a general appearance of the deposit. In the middle of the superheater the deposit reached a maximum thickness of 0.010 in. in thickness. Scattered areas of deposit were also found in the outlet region of the superheater. The thickest deposit in this region was found near a weld area (Section No. 25, weld). As shown in Figure 42 (Section No. 25, weld) the deposit was crescent shape and .014 inch thick.

Figure 40. Macrograph of the I.D. Surfaces of the Sections Removed from the Middle Region of the Superheater (Section Nos. 22 and 23).

Throughout the rest of the superheater various areas were found that had a gray-black surface, whereas others were silvery in nature. In several places, a metallic-like build-up along the tube wall was found which followed the contour of the swirl wire where the swirl wire came into contact with the tube wall. The general appearance of the inside tube walls described are shown in Figure 40.

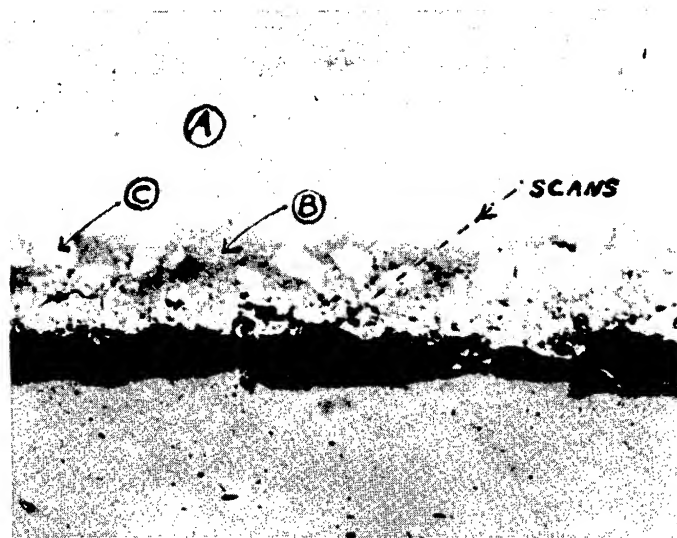
The analyses conducted on the two specimens from the boiler outlet region support the results obtained on wet chemical analysis of the deposits removed from the inside tube wall. However, three different compositional areas were found in the deposit along the surface of specimen Section No. 17, thermocouple No. 13. The grayish appearing phase is similar in composition to the corrosion layer found along the surface of the specimen Section No. 16, thermocouple No. 11 (Figure 46). As shown in Table 18, this phase is high in cobalt and tungsten with only small amounts of chromium and nickel. The white areas (marked C in Figure 47) within the deposit were found to be essentially the base metal depleted of chromium, whereas the edge of the deposit (marked B in Figure 47) was found to be essentially base material depleted in tungsten and nickel.

Figure 47. I.D. Surface of Specimen Removed from Section No. 17, Thermocouple No. 13, Showing the Microprobe Scan Path and Areas Analyzed.

From these results it appears that the surface of the specimen Section No. 17, thermocouple No. 13 suffered a leaching type of attack. And, a deposit of corrosion products filled the void areas left by the leaching of base material.

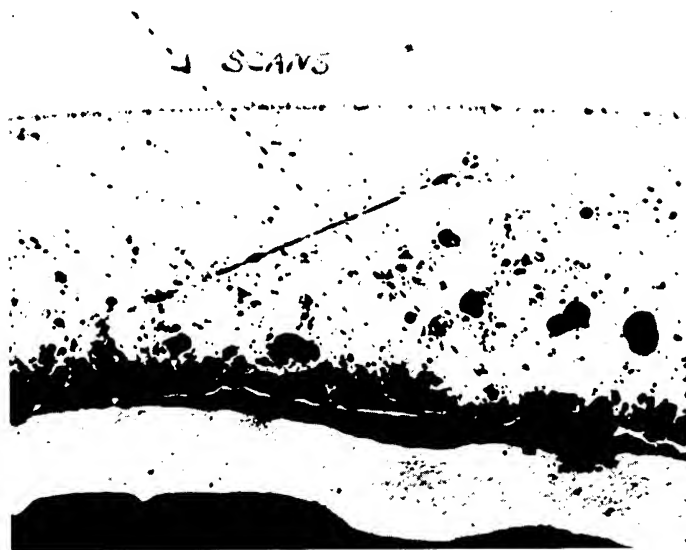
Figure 48. I.D. Surface of Specimen Removed from Section No. 20A, Thermocouple No. 18, Showing the Microprobe Scan Path.

Two areas of different composition were found within the deposit on the specimen Section No. 20A, thermocouple No. 18. As shown in Table 18, the bulk of the deposit (Figure 48 and marked C in Figure 49) was predominantly nickel with about 25 to 27 percent chromium. Only minor amounts of tungsten, iron and cobalt were found. However, another phase, (marked B in Figure 29) was found that was almost pure chromium (98-99 percent). Cobalt, tungsten, iron and nickel were found only in small or trace amounts. The results of the analysis of the specimen Section No. 22, thermocouple No. 21 were approximately the same. However, the chromium-rich phase was present in a greater quantity within the deposit. Also, there was not the same amount of distinction between the phases as was found in the specimen Section No. 20A, thermocouple No. 18.

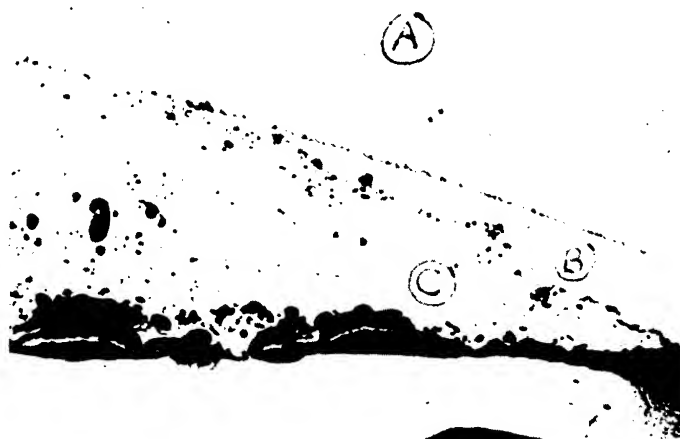
Figure 49. I.D. Surface of the Specimen Removed from Section No. 20A, Thermocouple No. 18, Showing the Areas Analyzed. This area is the area marked by the arrow in Figure 45.

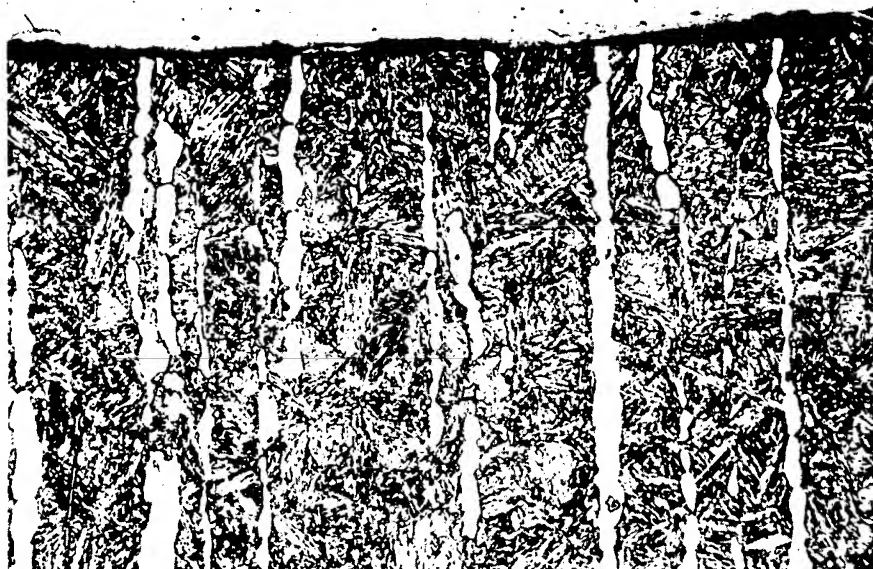
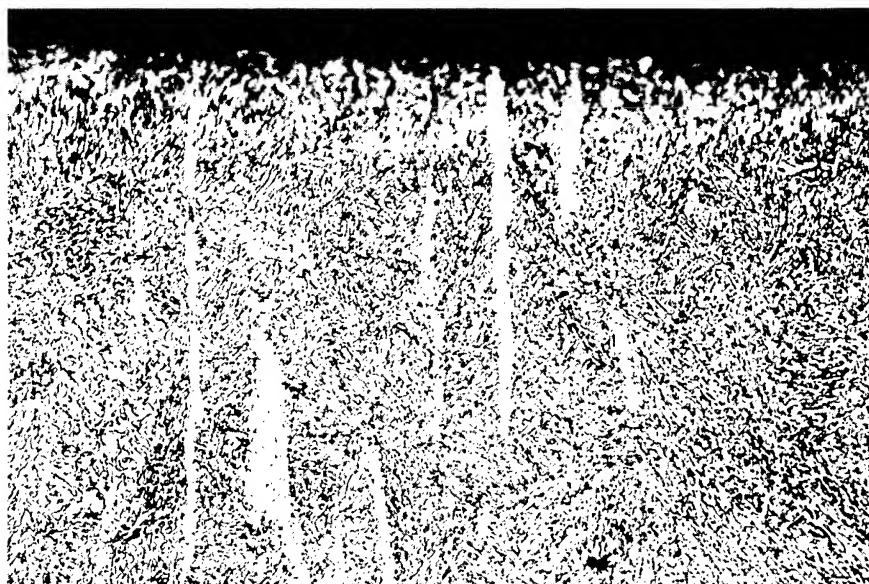
Figure 52 shows before and after test photomicrographs of the PH15-7Mo erosion specimen heat treated to the RH 950 condition. As shown by the photomicrographs, the edge of the specimen was relatively unaffected by the exposure to high velocity mercury vapor. However, as can be seen, the microstructure of the specimen in the after test condition changed from an acicular martensitic structure to that of a tempered martensite. Also as shown, carbon diffused into the ferrite stringers.

Figure 52. Condition of the Edge of the PH15-7Mo Erosion Specimen Heat Treated to the Condition RH 950.

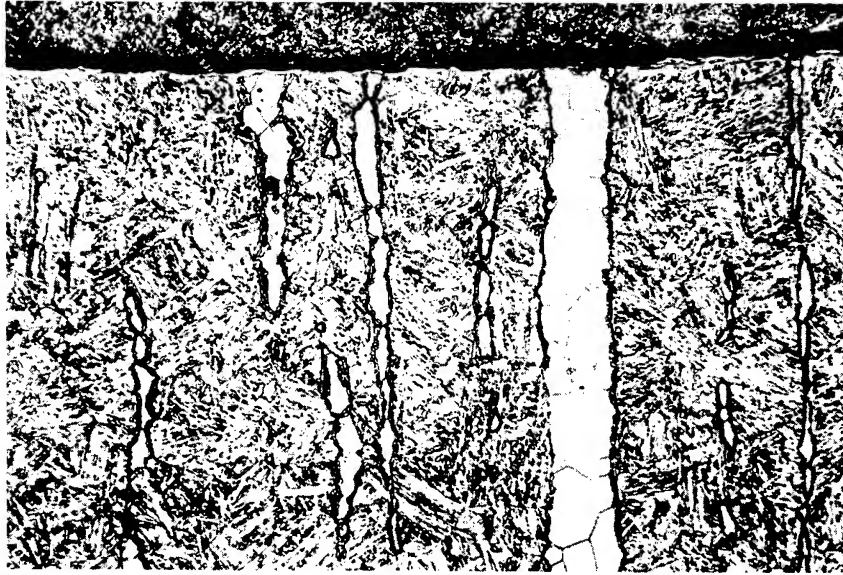
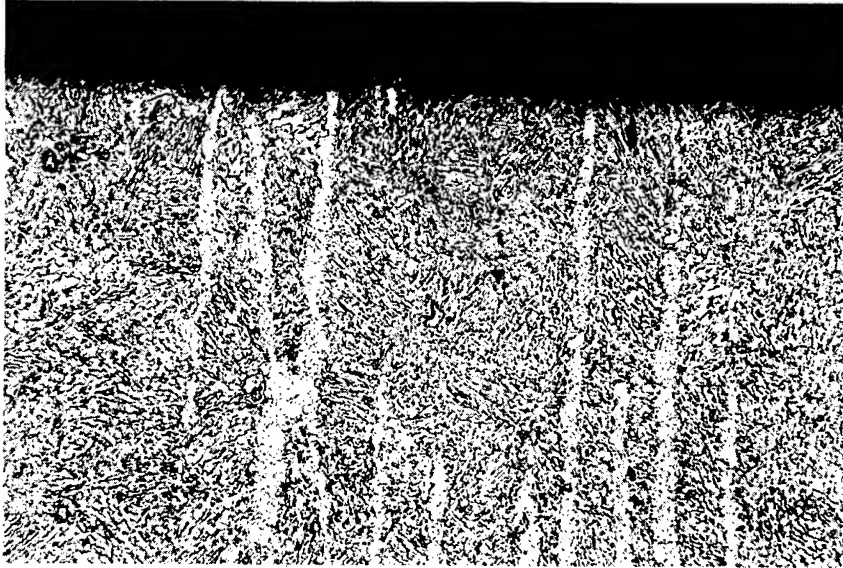
Photomicrographs in the before and after test condition of the PH15-7Mo erosion specimen heat treated to the TH 1050 condition are shown in Figure 53. As shown, the surface of the specimen was relatively unaffected by the exposure conditions. Also, the microstructure of the specimen in the after test condition changed as compared to the structure in the before test condition. The changes which occurred are essentially the same as those discussed for the PH15-7Mo erosion specimen heat treated to the RH 950 condition.

Figure 53. Condition of the Edge of the PH15-7Mo Erosion Specimen Heat Treated to the Condition TH 1050.

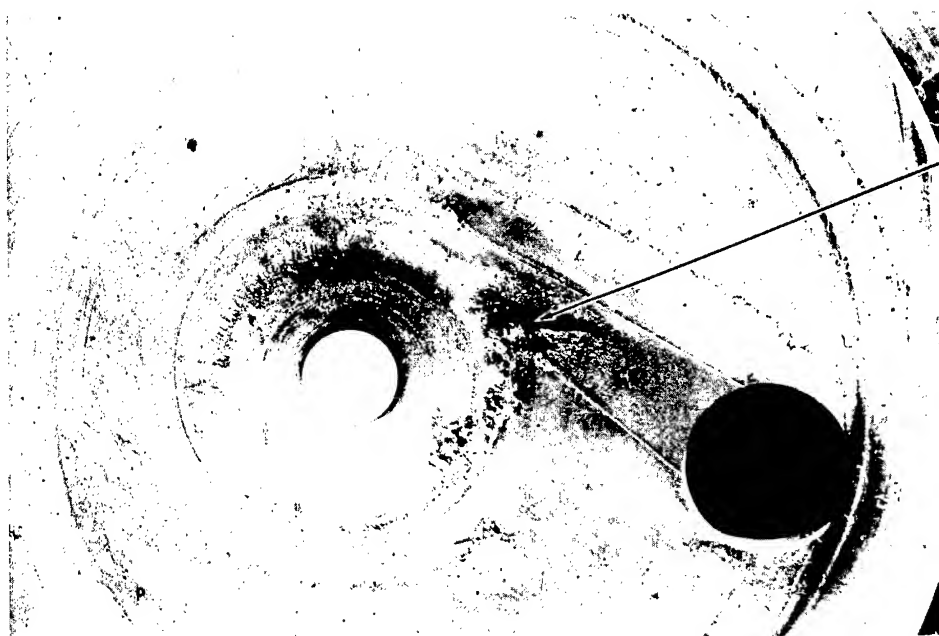
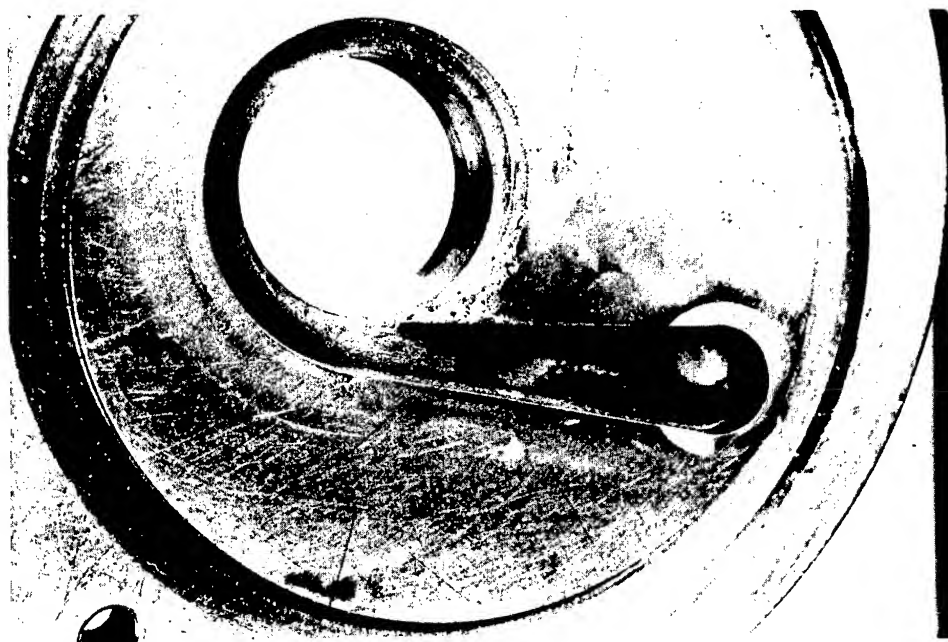
The final loop component to be examined was the centrifugal pump, which was fabricated from Type 316 stainless steel. The pump head was dismantled and examined visually for any possible damage. The pump components examined are shown in Figure 55. Evidence of cavitation damage was found only on the volute tongue. Figure 56 shows macrographs of the tongue and the extent of damage incurred. Sections were removed from the top part of the tongue (Figure 56) at the damaged area. These sections were then mounted and polished for metallographic examination.

Area where metallographic specimen was removed.

Figure 56. Macrograph of Centrifugal Pump Body Showing the Extent of Damage Incurred.

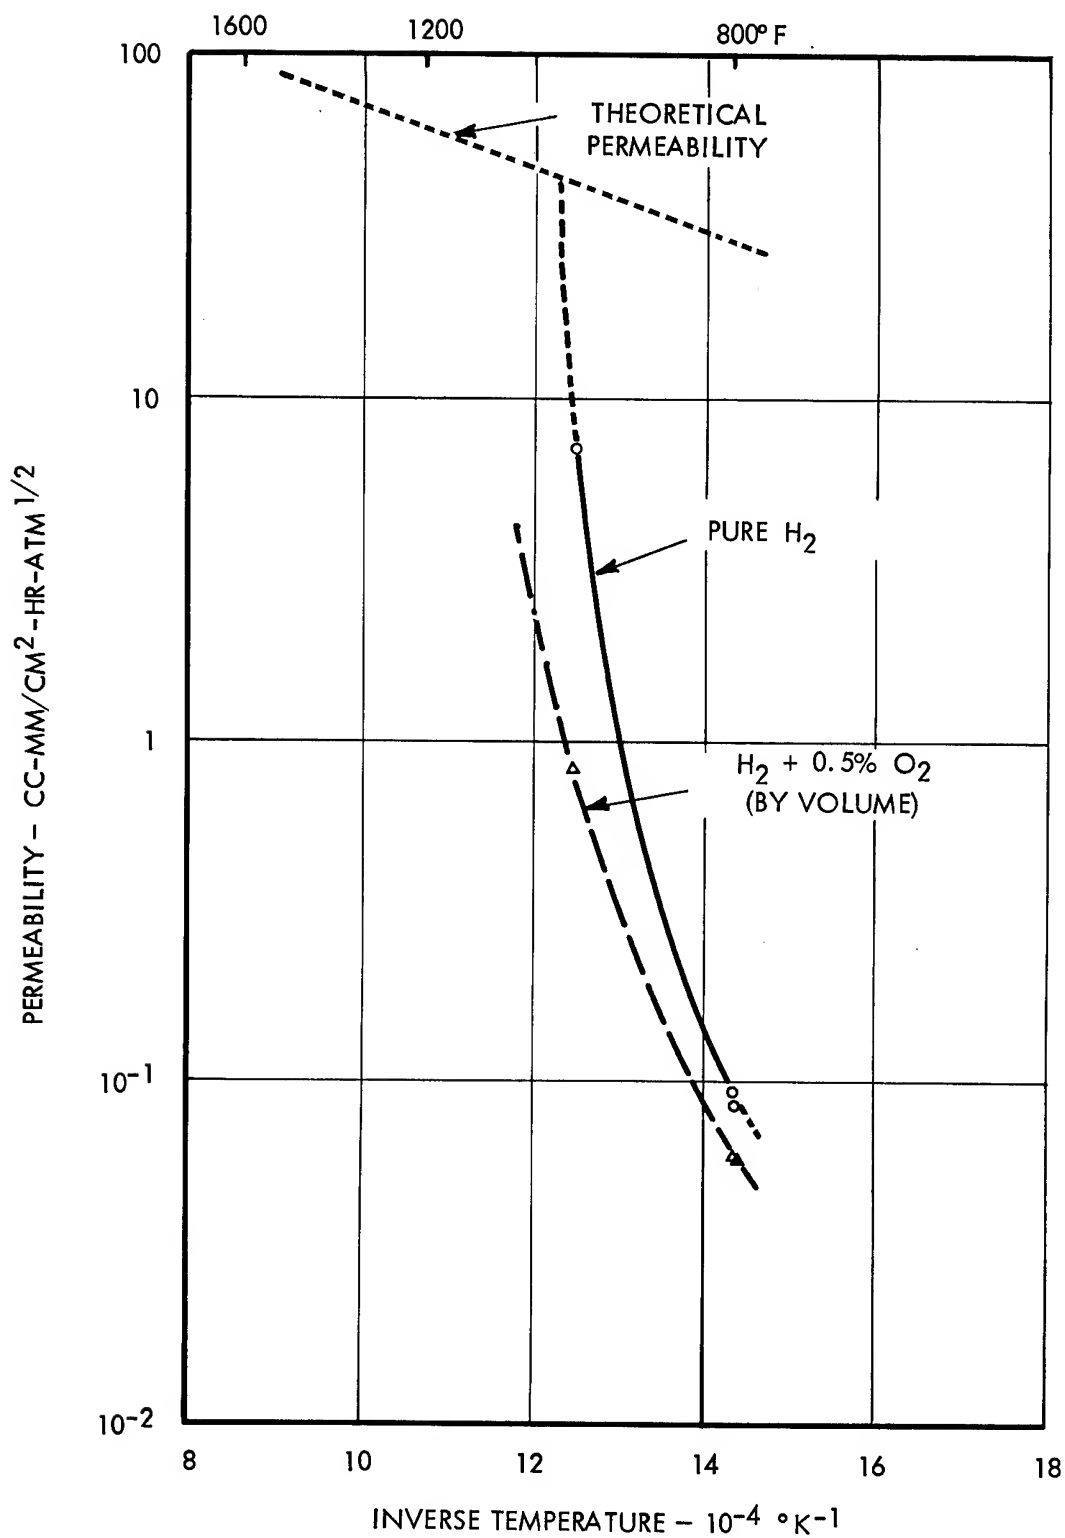
A tube test specimen was employed in this study. The experimental apparatus and method of analysis were identical to those previously described (10). The experimental results are summarized in Figure 64 where the permeability of pure and oxygen contaminated hydrogen through columbium is presented. As the temperature increases (approaching 1200°F) the permeability of uncontaminated hydrogen approaches the high value predicted by diffusivity and solubility data. The presence of 0.5 percent (volume) oxygen in the hydrogen produced a slight decrease in the hydrogen permeability. The relatively small effect produced by the rather large degree of oxygen contamination, particularly at the lower test temperature, suggests that the small amount of oxygen adsorbed on the tube wall does not represent a significant factor controlling the low permeability at low temperature. Also, the results indicated that improved cleaning or bake-out methods to remove adsorbed oxygen would not improve the permeability of columbium at temperatures of 600°F and lower to any significant degree.

FIGURE 64 PERMEABILITY OF HYDROGEN AND OXYGEN CONTAMINATED HYDROGEN THROUGH COLUMBIUM

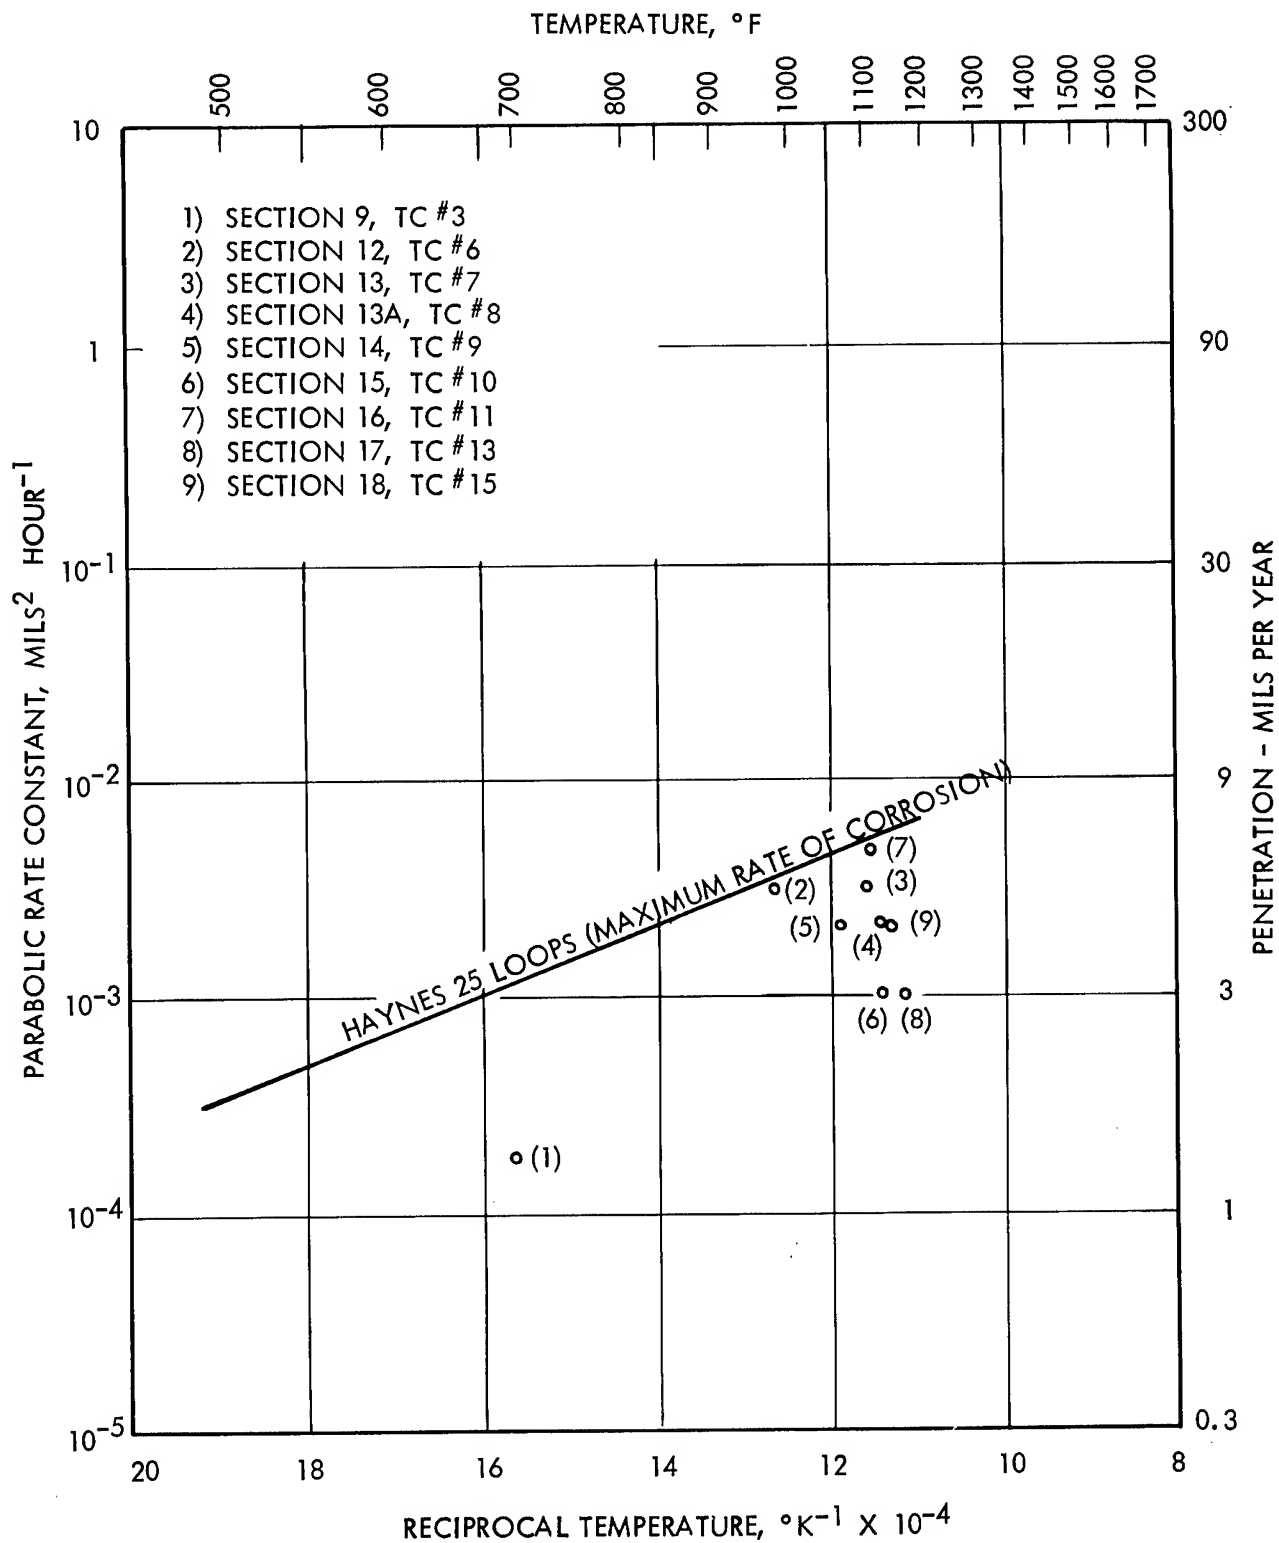
In general, the depth and mode of corrosion incurred in the boiler regions compare favorably with results obtained from previous corrosion tests. As shown in Figure 65, the attack incurred has been plotted as a function of the temperature. The results as plotted fall below or near to the curve, which is the maximum expected corrosion rate plotted as a function of the temperature (3).

However, the data, as plotted, should be used only for comparative purposes. As discussed with the results on metallographic examination, the temperatures listed for the various specimens are not truly representative of the total operating life. In view of this, the results seem to confirm the previous data on the corrosion of Haynes alloy No. 25 as obtained from thermal convection loops and capsule tests (2) (4).

FIGURE 65 COMPARISON OF HAYNES ALLOY NO. 25 MERCURY PENETRATION FROM THE WORK HORSE LOOP WITH TWO-PHASE THERMAL CONVECTION LOOPS
